# **2026-27 Potential Capital Projects**

**Draft – for August 2026 Board Meeting**

# Hotel Lakeside ... North Wall and 18 Rooms \$1.4M

# Fountain Inn Stucco Repair Areas

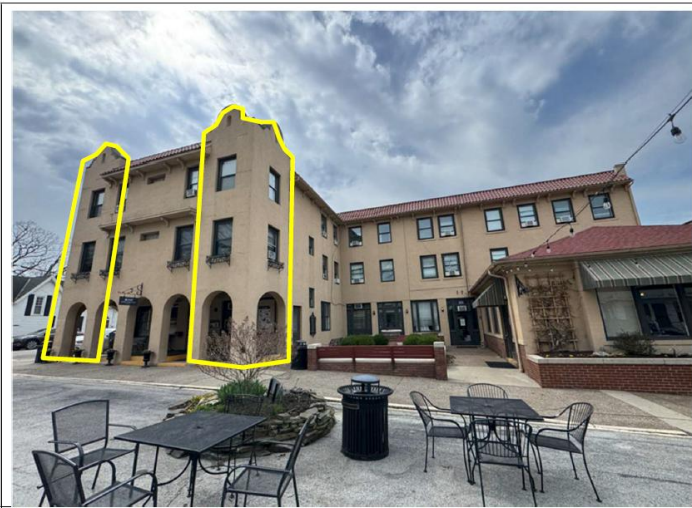
Overview of east façade. Concentrated concern areas are highlighted. Typically, these are below the arched caps.

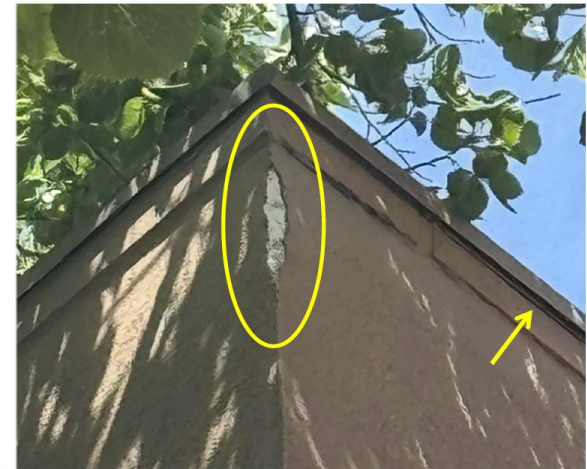
This is a typical tree scrape where a chunk of the system has been ripped away leaving exposed insulation. This should be fixed before winter. It also appears that there is a failing sealant joint at the top of this wall. We need to get a closer look.

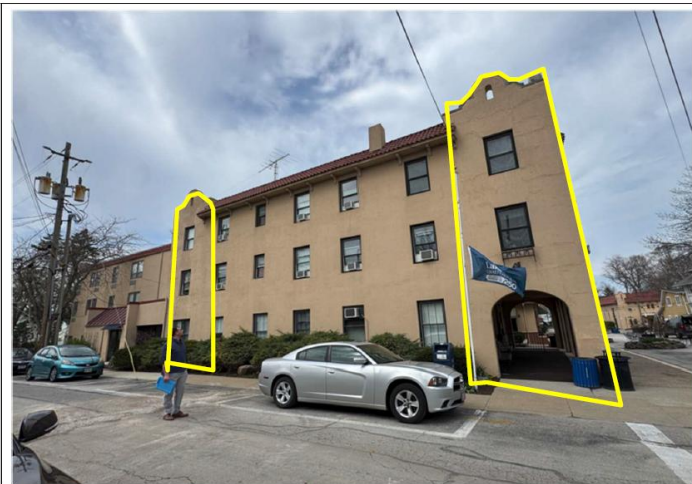
Overview of southeast façade. Concentrated concern areas are highlighted. Typically, these are below the arched caps.

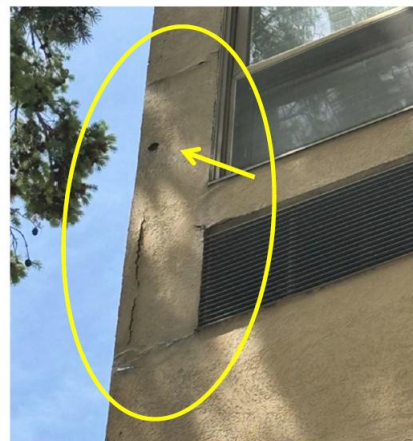
Fracture with large gap, poorly repaired. Also a bird hole above it. This entire area is an issue and should be repaired before winter.

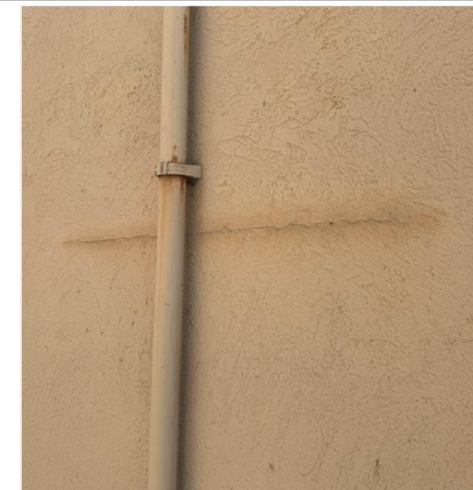
This fracture along an EPS insulation board joint has allowed water to penetrate which is exhibited by the dark coloration around the crack.

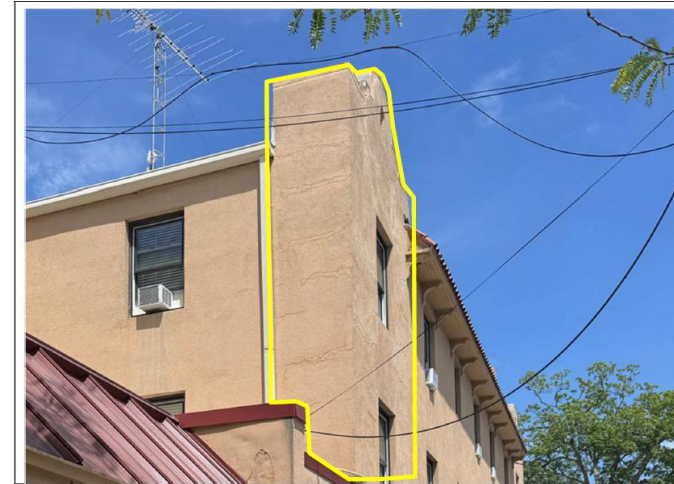
Notice the system to the left of the downspout is in much better condition. More evidence that the stone caps are the culprit.

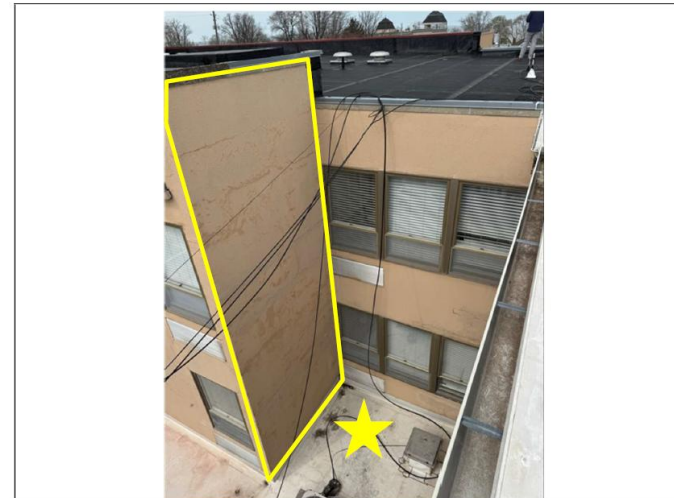
Similar to what we see below the arched stone caps, the wall on the left has obvious water damage and evidence that it could be debonded. It should probably be replaced. This is also an area where the office leak was reported. We should inspect the wall and the roof transition details to better understand what is going on here.
